## **Inspection of works, 14-17 Moore St.**

**19<sup>th</sup> January 2017**

An inspection of the ongoing Essential Works being carried out at 14-17 Moore St. and as approved by the High Court, was undertaken on 19<sup>th</sup> January 2017.

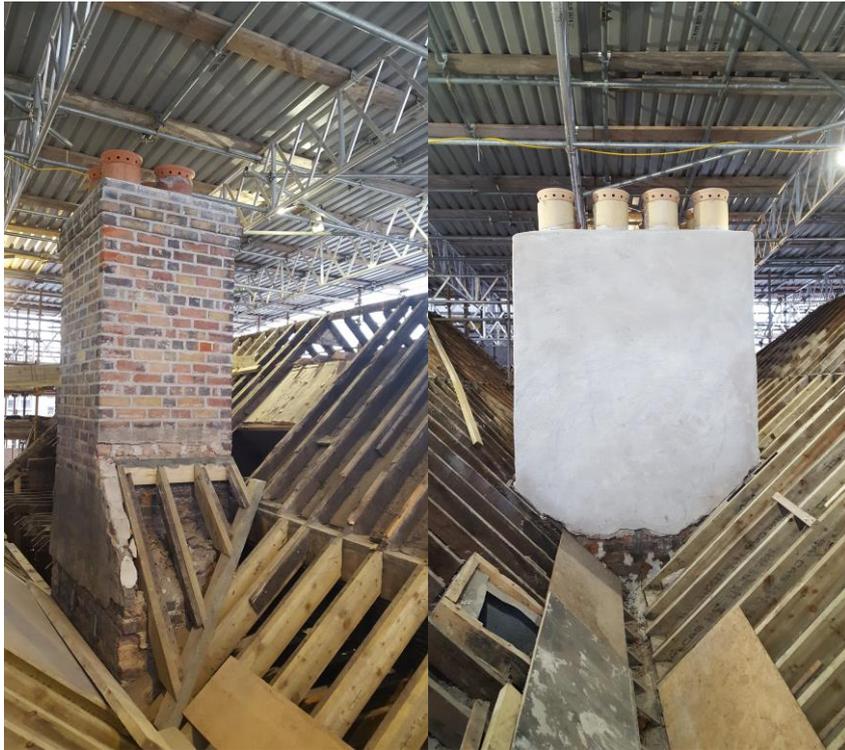
Completed chimney stacks (Photo: J. Donnelly)

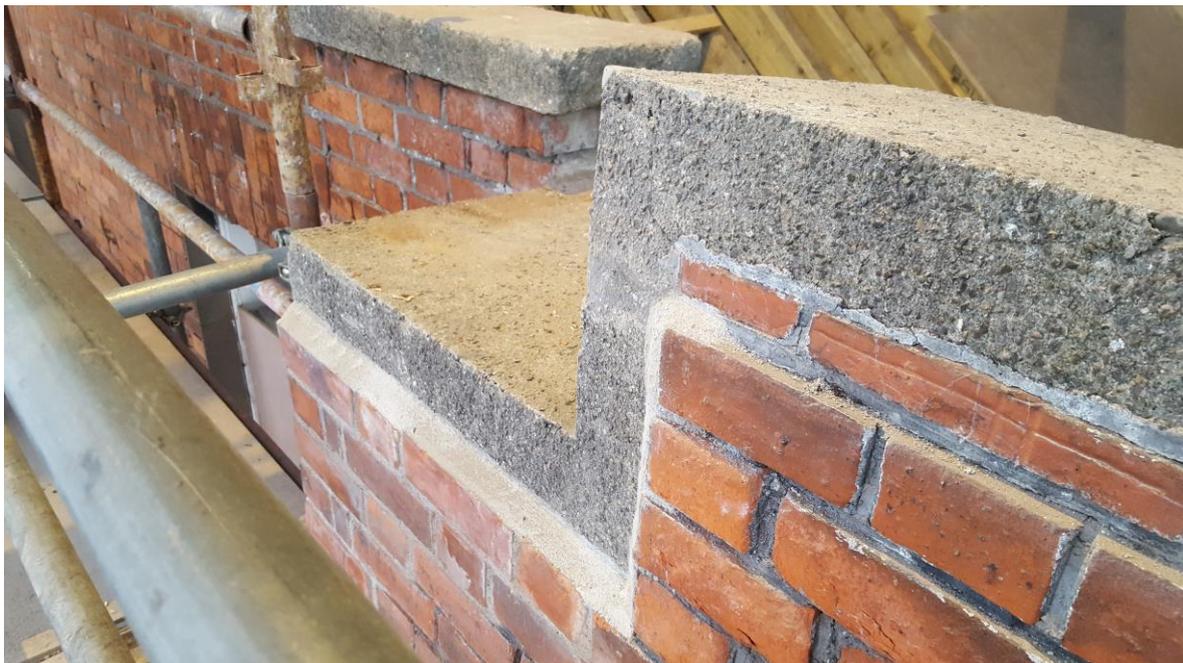
Repaired parapet, no. 14 (Photo: J. Donnelly)

Work is currently concentrated at roof level. Remedial works have been carried out on the parapet at the front of no. 14 with the result that it will not now be necessary to dismantle any portion of the parapets. At the rear of no. 14, a section of brick wall has been dismantled and rebuilt to support the roof structure. The small slates from this section of roofing have been set aside and sound slates will be reincorporated in the reroofing. Further opening-up has taken place at the back of all four buildings. The rear gable of no. 17 will require partial dismantling and the insertion of a steel lintel – the temporary propping required in no.16 to allow this work to proceed has been designed and the dismantling is due to commence on January 20<sup>th</sup>. The steel for no. 17 has been ordered and the steel for the building at the rear of no. 14 is already on site. A further decayed timber lintel has been identified at the rear of No.15 and may require the dismantlement and rebuilding of a small triangle of masonry above.

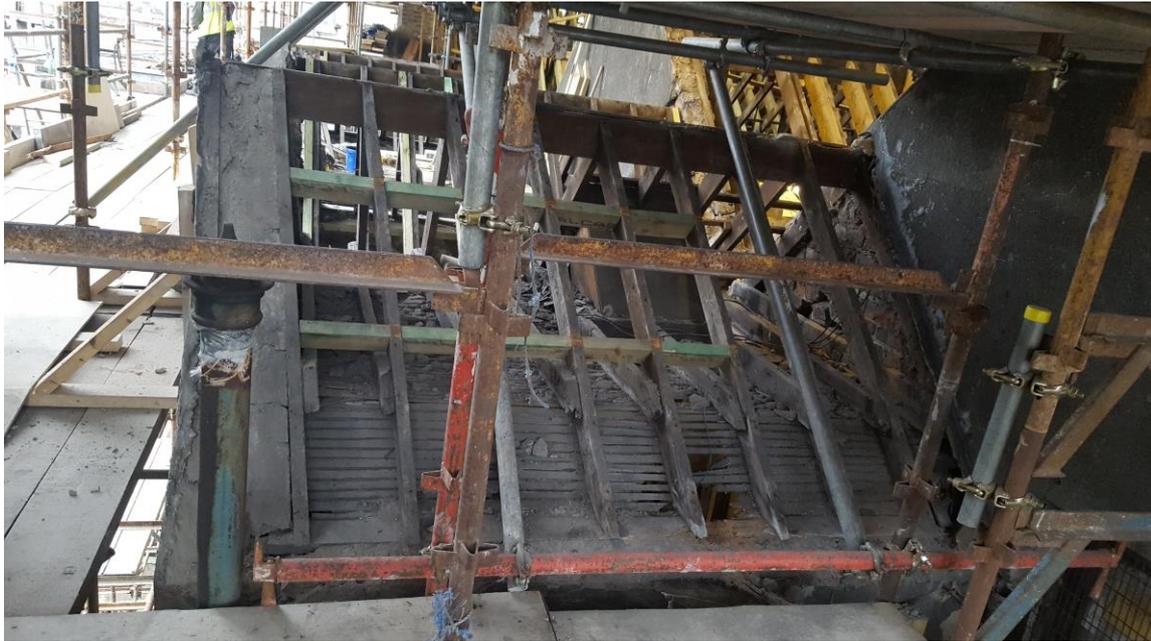
Return at rear of no.17 with unstable gable propped (Photo: J. Donnelly)

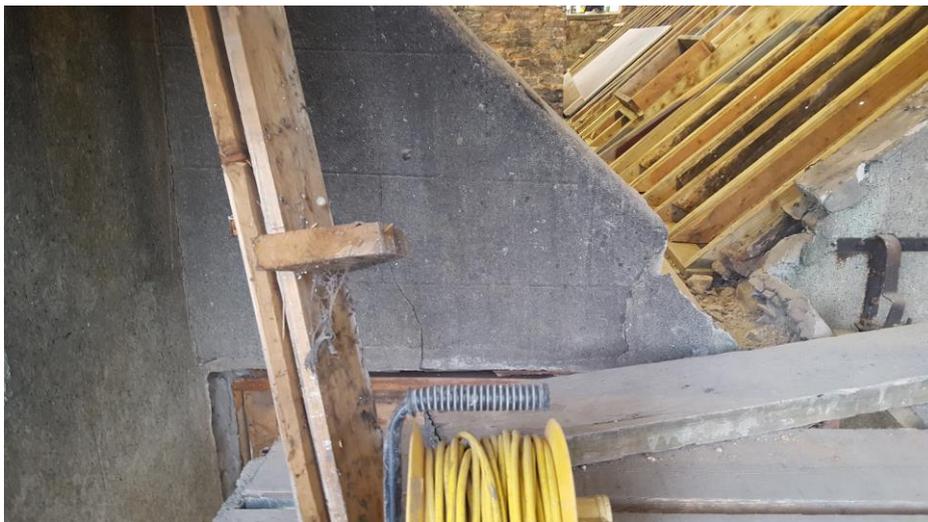
Triangular area at rear gable of no. 15 with decayed lintel below (Photo: J. Donnelly)
